OLD BRANSON HIGH SCHOOL

ANALYSIS AND COST ESTIMATES

August 20, 2012

A study prepared for the City of Branson to assist in reviewing options for the Old High School property.

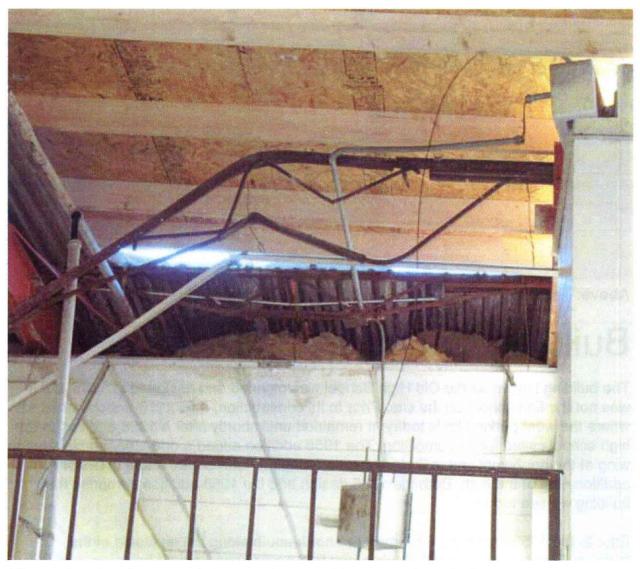
Above: Roof and structural damage from the February 29th, 2012 tornado to the two-story north wing,

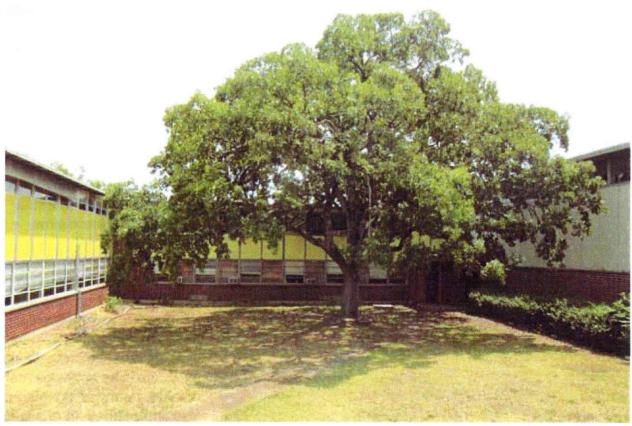
Retaining the exterior wall panels on the gym that contain asbestos was also reviewed. Estimates provided by Sunbelt Environmental Services reveal that abatement of all of the asbestos panels amounts to an approximate cost of \$12,870. Nearly half of the panels are on the gym. If these panels were retained, it might yield a savings of half of the \$12,870 removal cost. However, if a panel was retained and damaged during building occupancy by tenants or the public, it would have to be abated in an approved manner.

Above: Exterior wall paneling (yellow: Transite, white: Cem-bestos) made with asbestos.

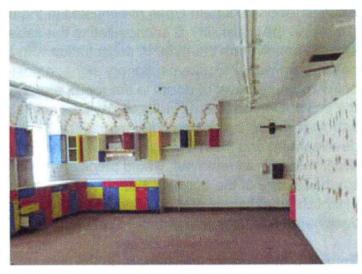
Above: "popcorn-texture" ceiling in clasrooms contains asbestos.

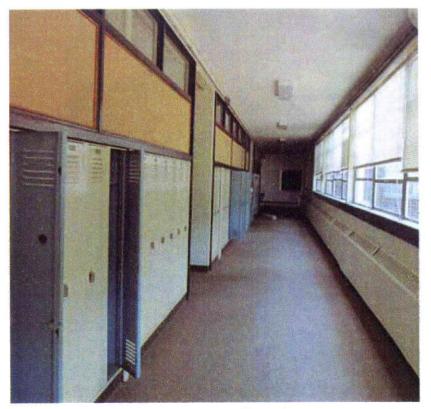
Above: "popcorn-texture" ceiling containing asbestos in hallway.

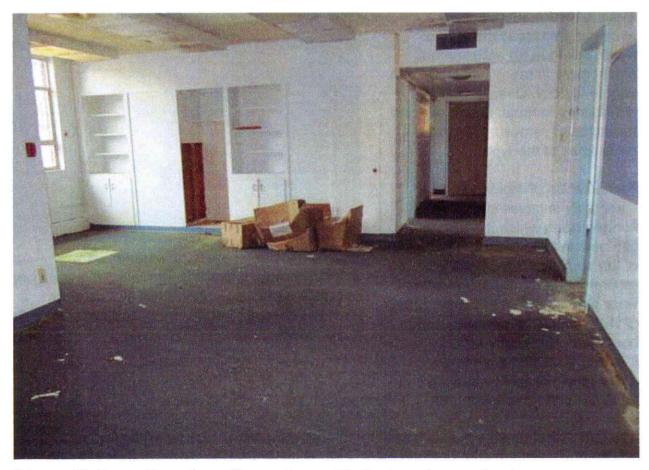
Above: Mold growth on the ceiling and carpet in the two-story north wing.

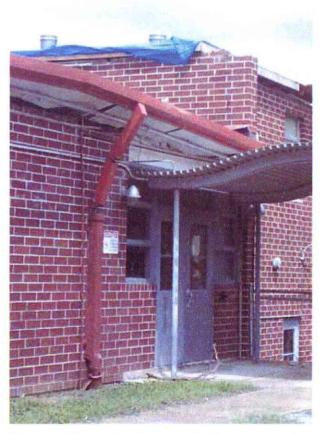
Above: Tornado damage to the north wing with the roof separated from the walls.

Structural engineer Tom Edelman visited the site twice to view the structural damage. He observed that the roof on the north two-story wing had been lifted up and then released to fall back onto the walls. The walls were out of plane when the roof came back down, thus they were trapped into that condition by the weight of the roof when it returned.

Most of the tornado damage occurred to the west end of the two story wing. Here, parts of the roof construction were separated from the wall. In addition, the roof was damaged to a level that allows rain and debris to enter into the interior spaces. The City has installed temporary tarps over the roof to limit exposure of the interior to the elements. However, the mold in this portion of the school is so extensive that it would be difficult to work in this area until the mold is abated.

have broken connections in some visible locations. The only way to know the extent of the broken connections would be to remove the roof. If it is desired to retain this wing, then the roof needs to be removed to expose the bar joists and their connections for examination. We would expect to find that the metal pan deck is also warped - however that cannot be observed until it is exposed.

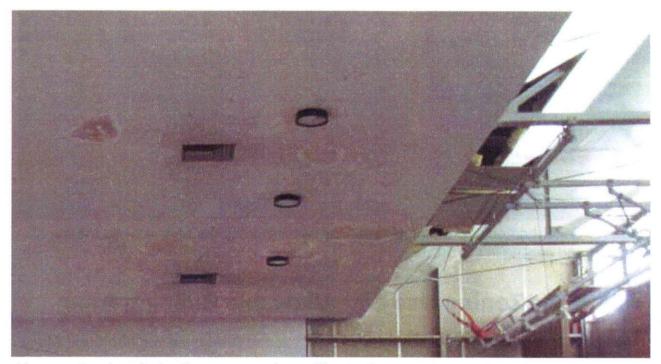
Surfaces inside the building have been damaged by water infiltration from leaks in the roof and walls. Water damage has been observed throughout the North wing and in other locations throughout the building. Some water damaged materials can be easily fixed, such as water staining on concrete. Other materials will be more difficult to repair, and may require removal and replacement.

Above: discolored circular spots on the ceiling indicate evidence of roof leaks in the gym.

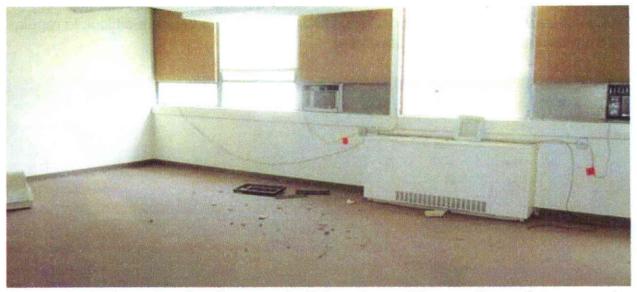
There are two separate HVAC systems in the building. One, for heating, is a system of radiators connected to a boiler. Two, for cooling, is a series of window air conditioner units. The window air conditioners are not in fully operational condition, and do not provide adequate cooling for any future lease space requirements.

Above: Boiler-heated wall radiators and window air conditioner units are the means of heating and cooling in the building.

Rooftop mounted multi-zone units would be the most effective system to provide heat and air conditioning to the white box and final floor layout. The multi-zone units would initially be ducted to supply each major area of a tenant's space and each zone would have its own thermostat. This design would allow

the building to be conditioned and protected until the final construction is completed. Approximately 180 tons of capacity is required to condition the entire building. In the white box application the ducts would merely extend into each major space. When the exact plan and use of each space is further defined the ducts would be extended to serve the final room layout.

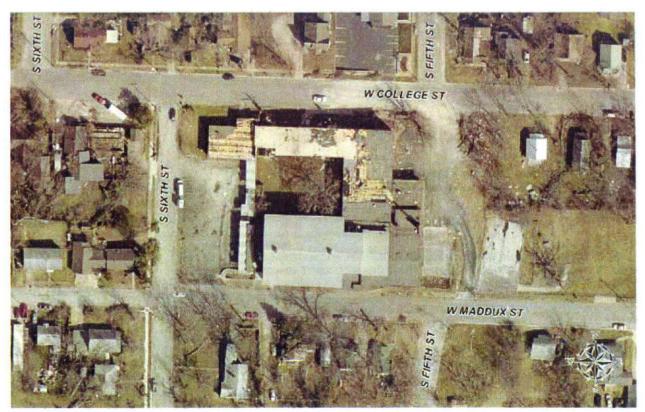
Aerial photo of February 29th tornado damage

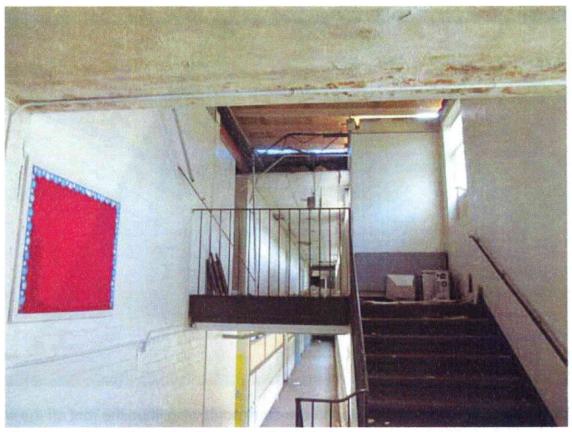
Above: water and structural damage in the two story north wing.

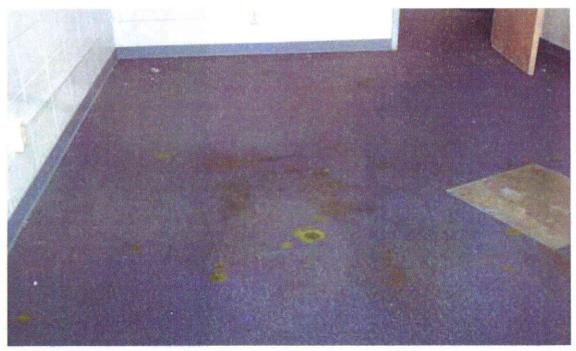
Above: Extensive mold growth on interior surfaces.

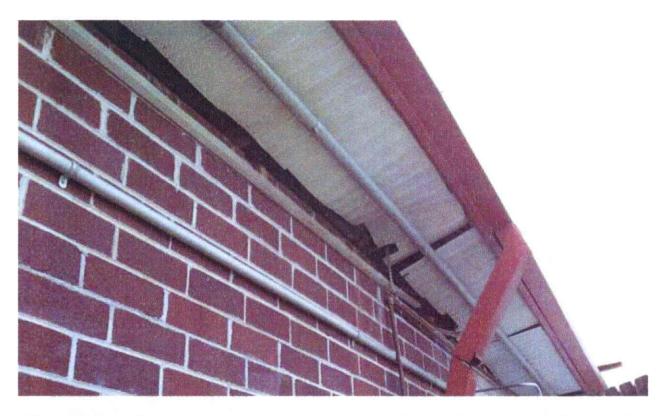
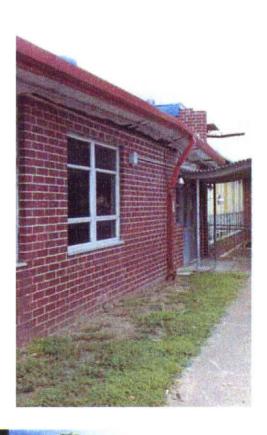
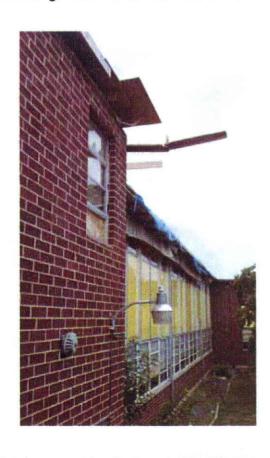
Above, below: Tornado damage to the two-story north wing lifted the roof off the walls.

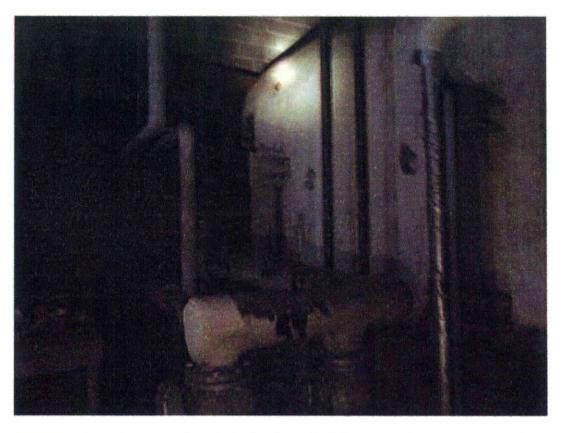
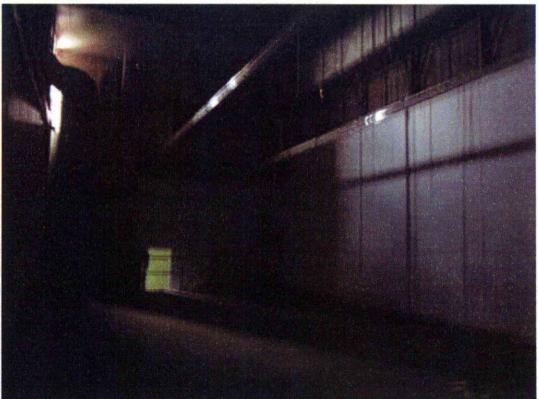
Above: Asbestos pipe-wrap throughout building.
